**CALSPAN ON-SITE AIR BAG DEPLOYMENT INVESTIGATION
CALSPAN CASE NO. 94-14
VEHICLE: 1994 OLDSMOBILE NINETY EIGHT REGENCY ELITE
LOCATION: [REDACTED]
CRASH DATE: [REDACTED], 1994**

14. Sponsoring Agency Code	
15. Supplementary Notes On-site investigation of an air bag deployment crash that resulted in multiple fractures to the right hand of the right front passenger of a 1994 Oldsmobile Ninety Eight as she attempted to brace against the air bag module cover flap.

**Selected Color Prints
Calspan Case No. 94-14**

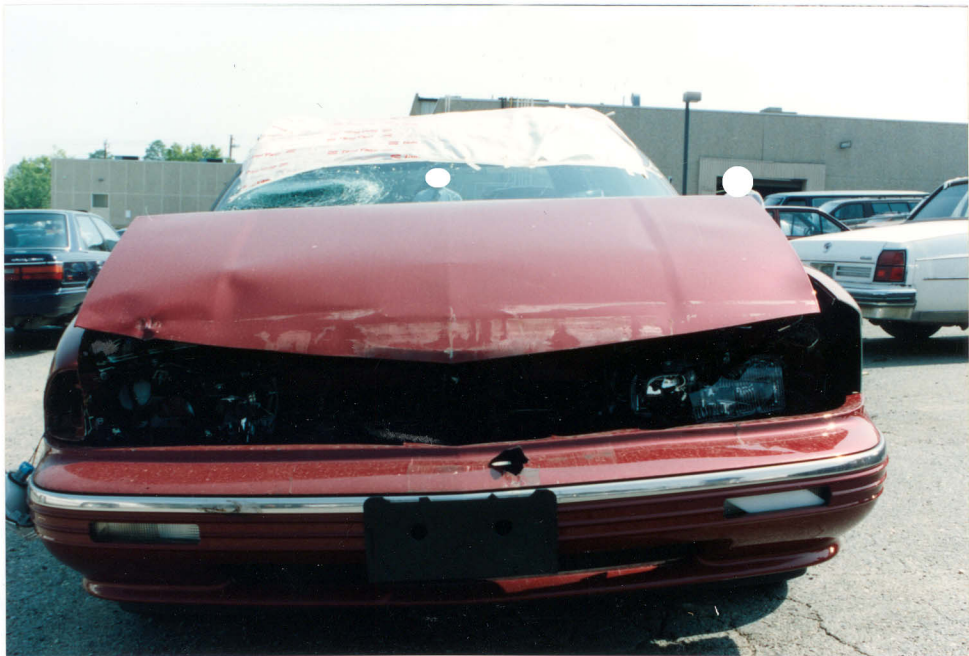
The 1994 Oldsmobile Ninety Eight sustained moderate frontal damage as a result of its front-to-rear impact sequence with the stopped Ford Ranger (vehicle #2). In an attempt to avoid the crash, the driver of the Oldsmobile applied a braking force which compressed the front suspension as the vehicle impacted the rear of the stopped Ford Ranger. The top surface of the front bumper fascia initially impacted then underrode the rear step bumper of the pickup truck. Damage to the fascia consisted of longitudinally oriented abrasions to top surface and a tear located 7.6 cm (3.0") left of the center that resulted from the trailer hitch stud protruding from the center of the rear bumper of the Ford Ranger. The center-mounted license plate frame was cracked as a result of the contact sequence. There was compression of the bumper energy absorbing devices (EADs) and no residual crush at bumper level. Both front bumper EADs remained in their original pre-crash position at 8.6 cm (3.375") in length (refer to Photograph Nos. 15 and 16). As the front bumper of the Oldsmobile underrode the rear bumper of the Ford Ranger, the grille and hood face area engaged against the bumper face and tailgate of the Ford Ranger. The direct contact damage was 140.0 cm (55.1") in length which extended across the entire width of the vehicle at grille level. The contact fractured the plastic grille and headlamp assemblies and deformed the air conditioning condenser, the center mounted air bag discriminating sensor, and the upper radiator support panel. Maximum crush was 25.1 cm (9.875") located at the radiator support panel 38.1 cm (15.0") left of center (refer to Photograph Nos. 13 and 14). The residual crush profile was documented at the upper radiator support level and was as follows: $C_1 = 9.1 \text{ cm (3.6")}$, $C_2 = 24.4 \text{ cm (9.6")}$, $C_3 = 19.7 \text{ cm (7.75")}$, $C_4 = 16.8 \text{ cm (6.6")}$, $C_5 = 14.2 \text{ cm (5.6")}$, $C_6 = 2.3 \text{ cm (0.9")}$. The leading edge of the hood sustained contact damage from engagement with the tailgate of the struck Ford Ranger. The contact damage began 12.1 cm (4.75") inboard of the right corner and extended 134.6 cm (53.0") to the left corner (refer to Photograph No. 7). The tempered glass sunroof separated from the vehicle and was found lying undamaged in the rear seat area of the vehicle. The roof sustained symmetrical areas of deformation directly rearward of the B-pillars on both sides of the vehicle (refer to Photograph Nos. 21 and 26).

6. Frontal damage to the Oldsmobile 98.

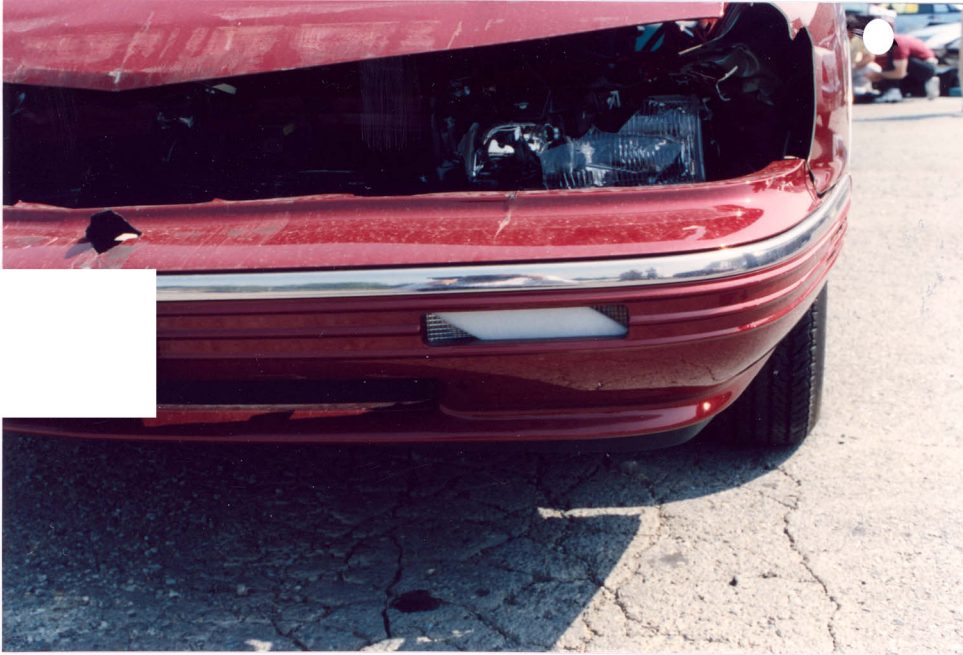
9. Close-up view of the face of the left front bumper fascia.

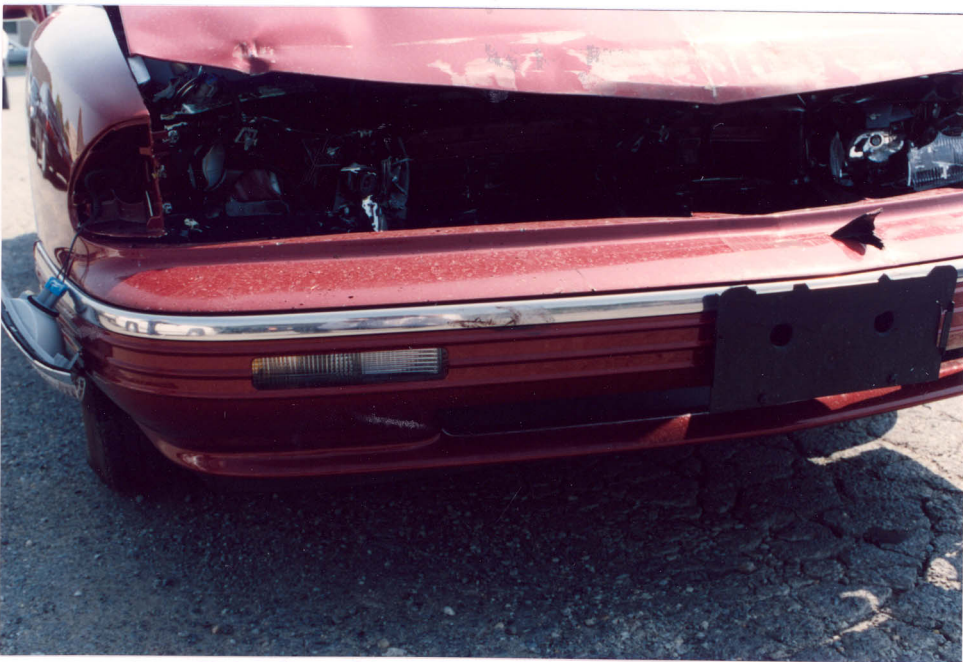
10. Close-up view of the face of the right front bumper fascia.

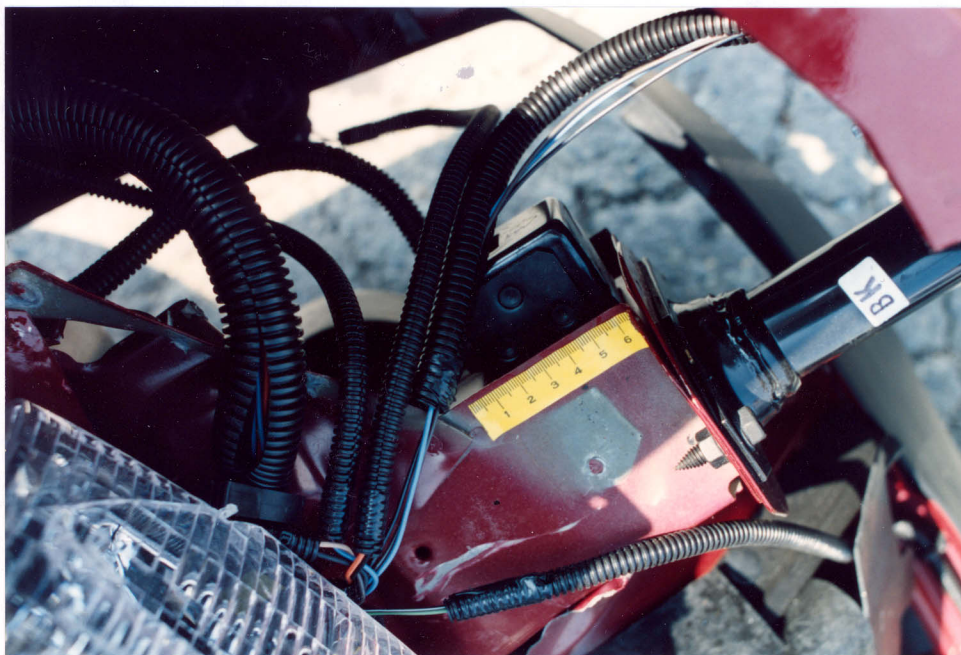
The two outboard discriminating sensors were mounted to the frame rails directly rearward of the bumper EADs (refer to Photograph Nos. 17 and 19). The third discriminating sensor was mounted to the forward side of the radiator support panel, adjacent to the left side of the hood latch assembly. The forward aspect of the center mounted sensor was slightly deformed as a result of the frontal impact (refer to Photograph No. 18), however, the deformation did not appear to have damaged the internal components of the sensor.

17. Left front discriminating (crash) sensor.

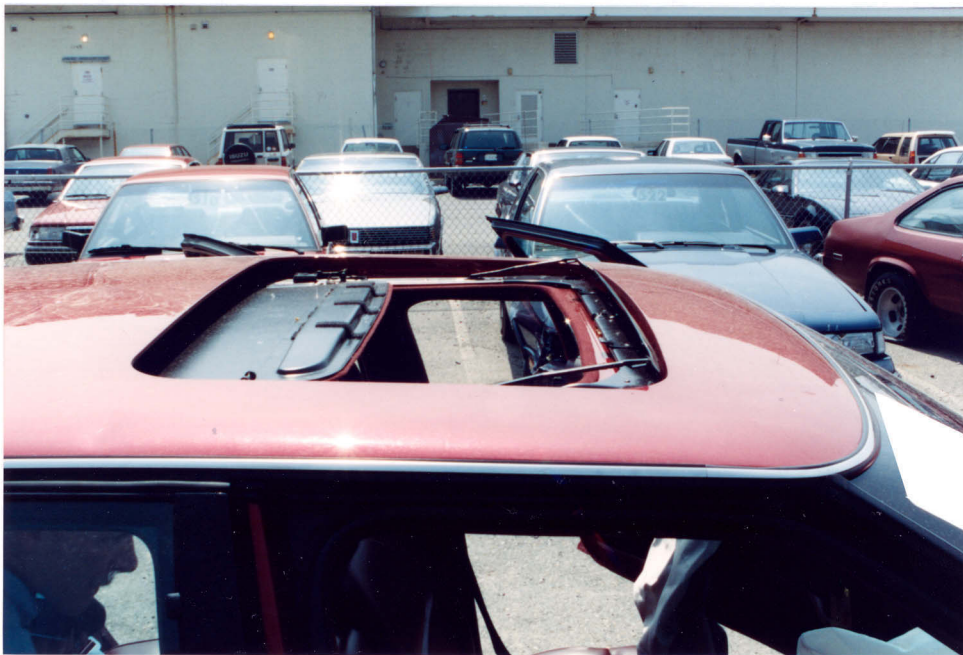
25. Tempered glass sun roof separated from the vehicle.

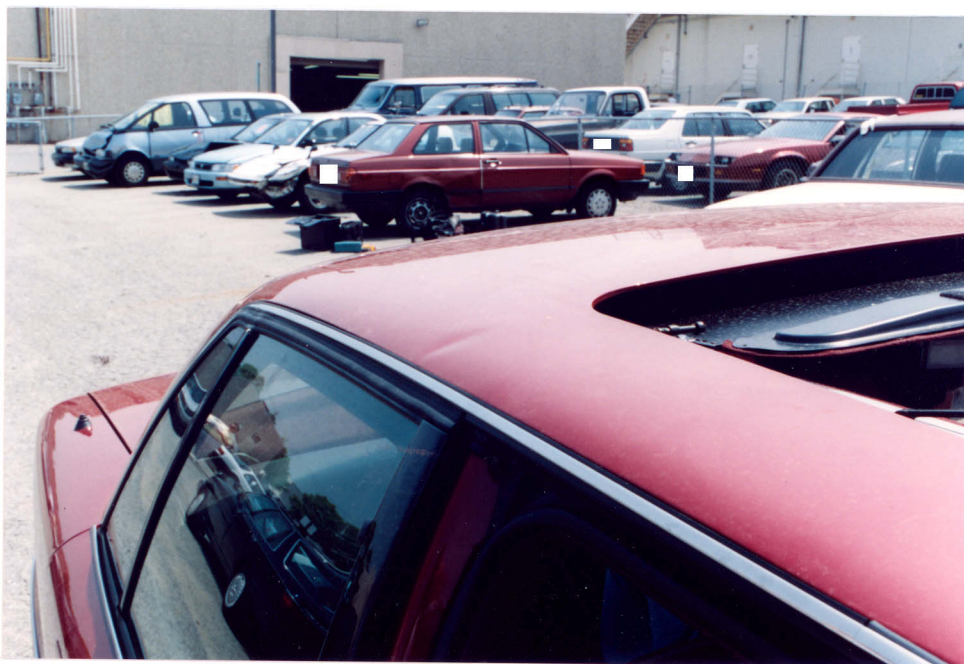
26. Induced deformation to the roof at the right B-pillar area.

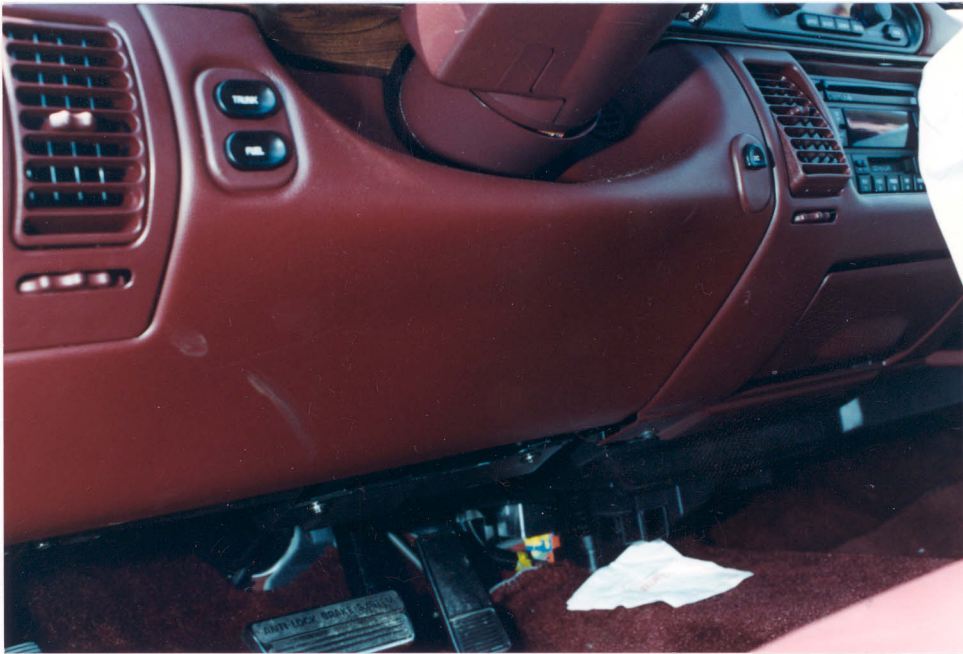
31. Knee bolster with probable foot scuff on left side.

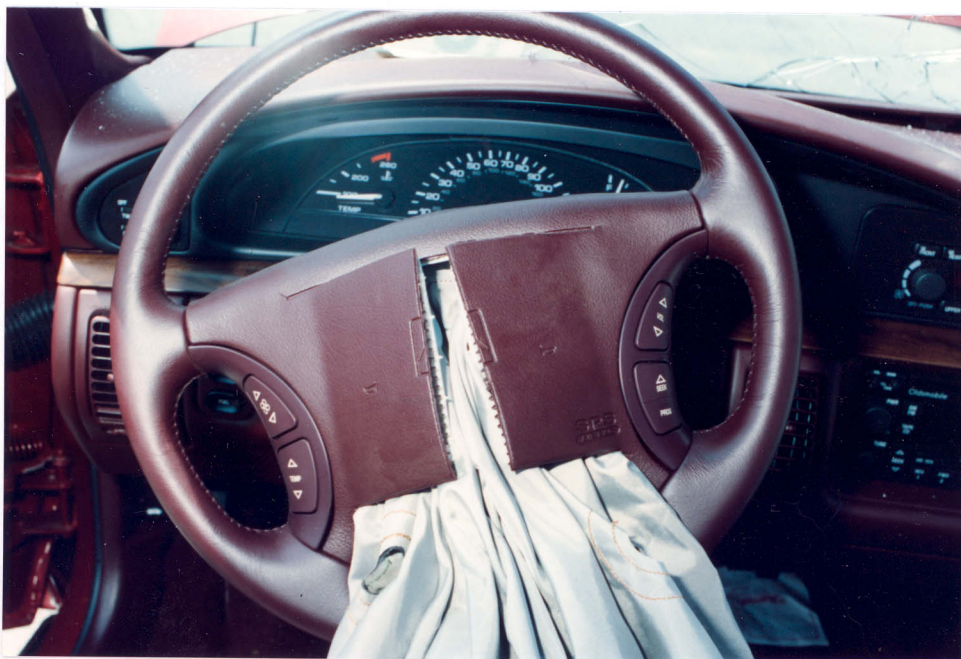
34. Vertical configuration of the driver's side air bag module cover flaps.

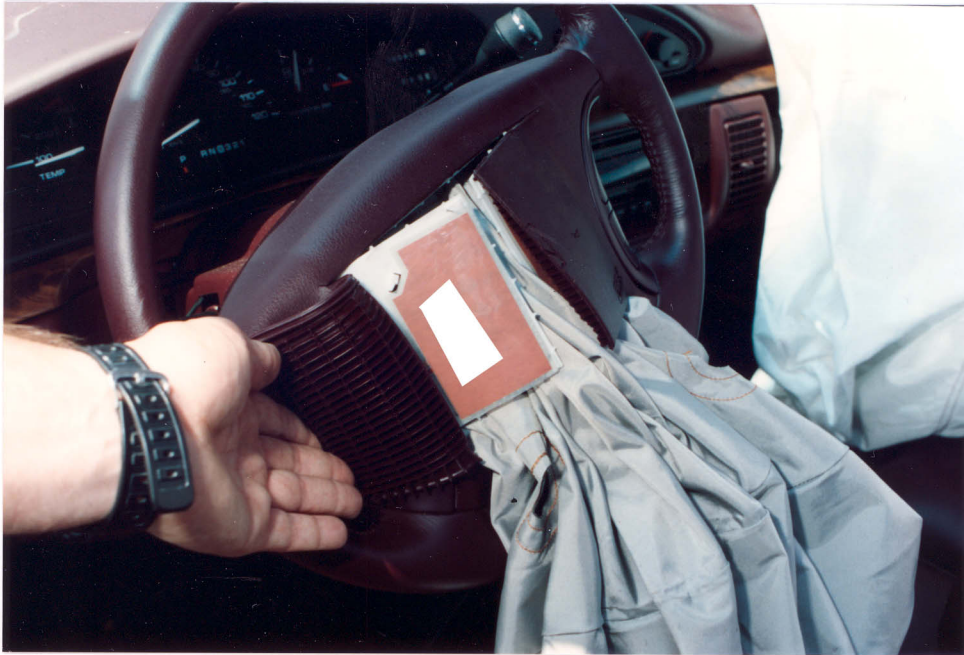
35. Horn contact pad located between module cover flap and air bag.

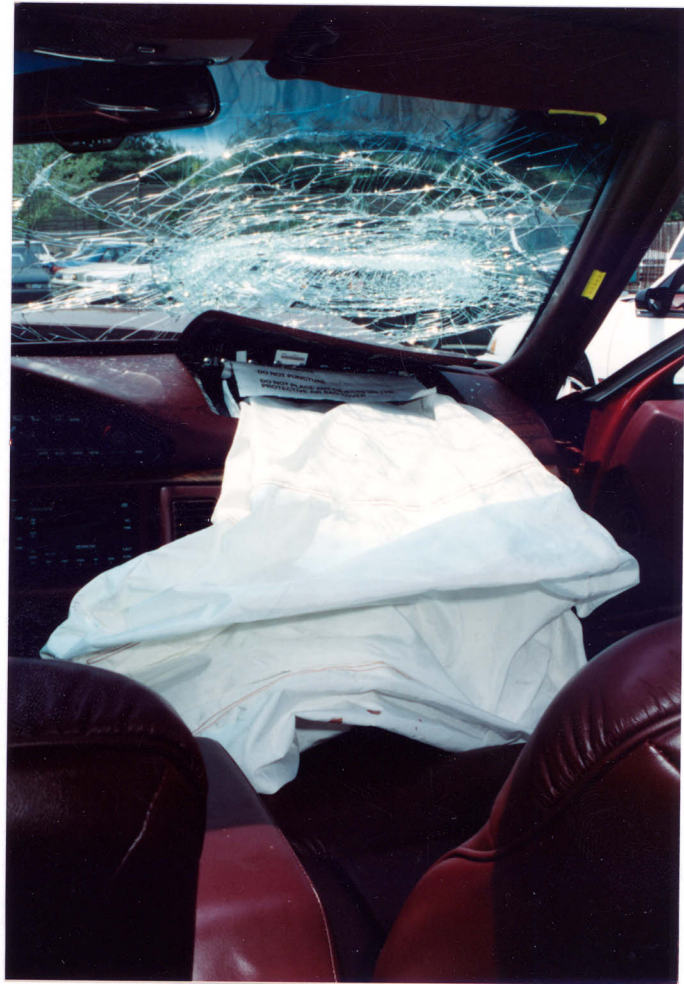
38. Overall view of the right front passenger compartment and deployed air bag.

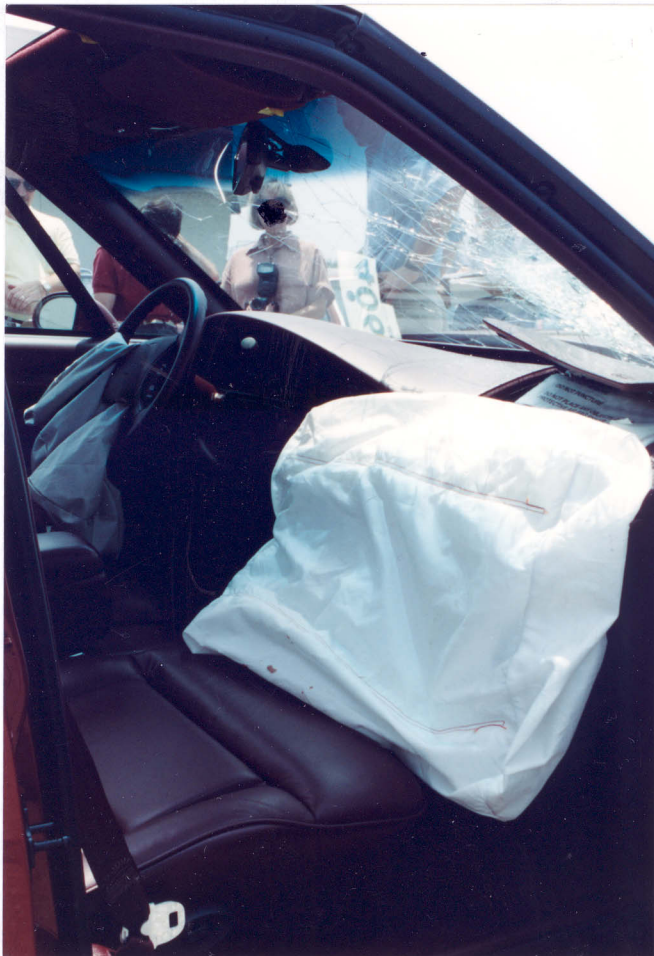
39. Deployed passenger side air bag.

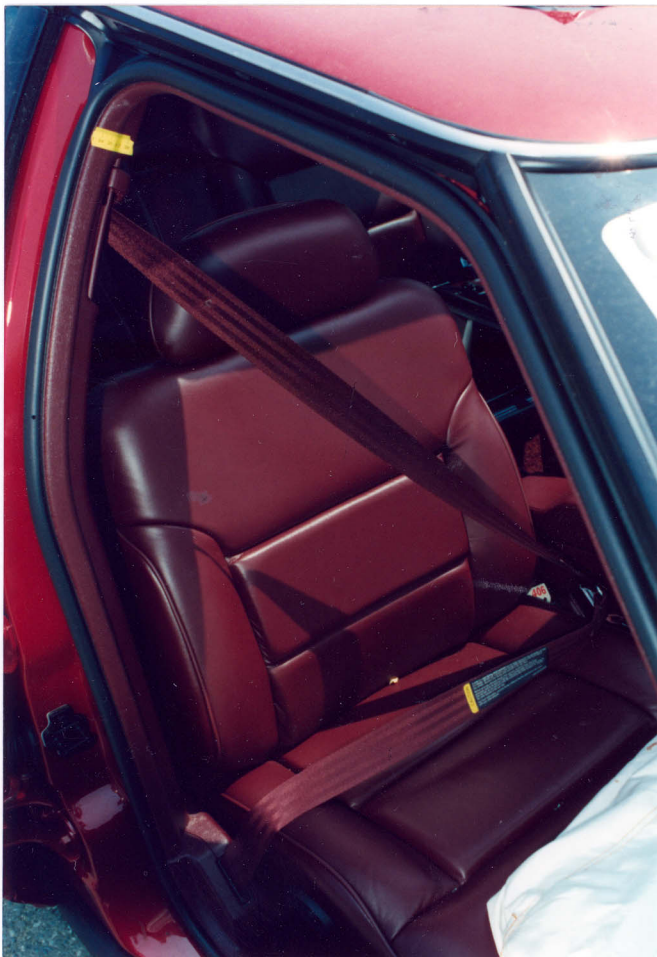
48. Passenger's seat and the manual 3-point belt system.

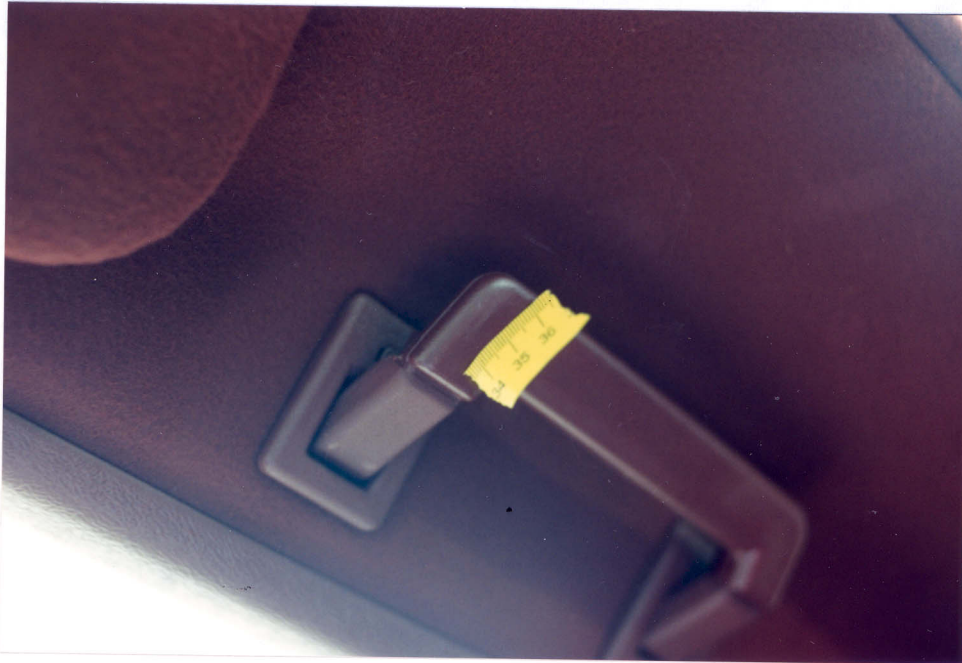
51. Scuff on the leading edge of the roof mounted right passenger assist grip.

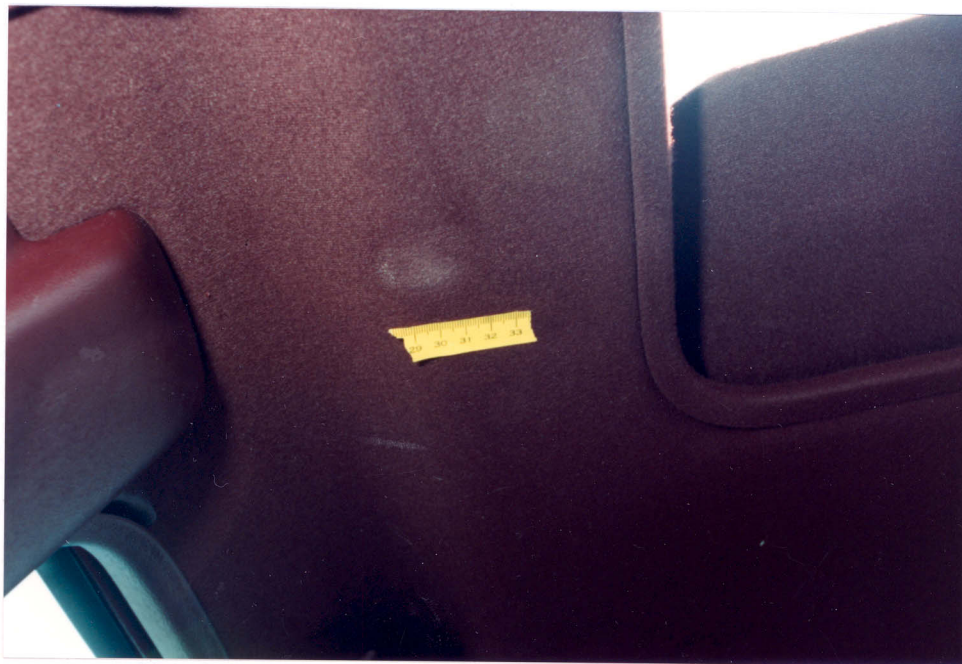
52. White powder transfer on the headliner inboard of the right B-pillar.

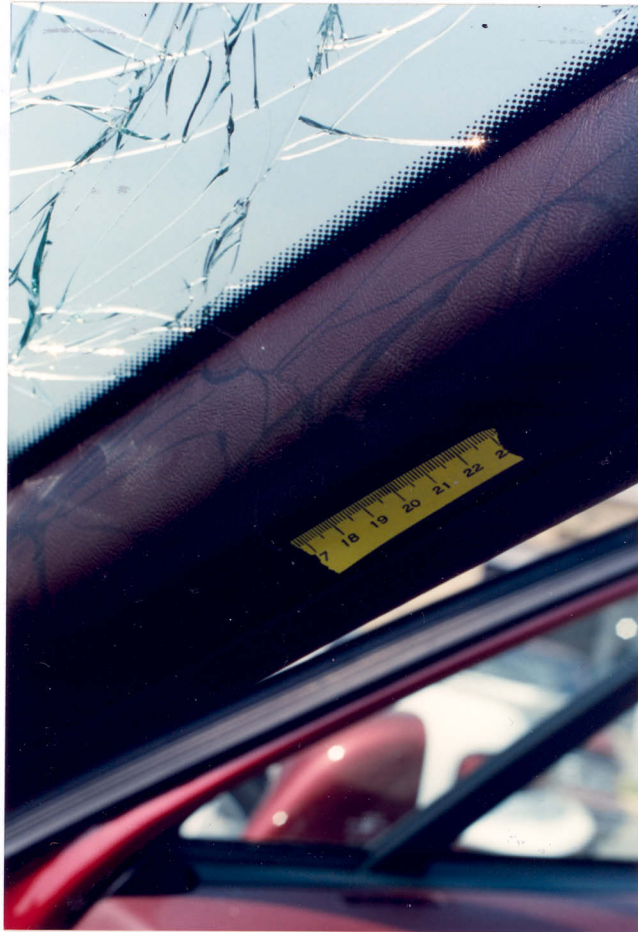
53. Scuff at the mid point
of the right B-pillar.

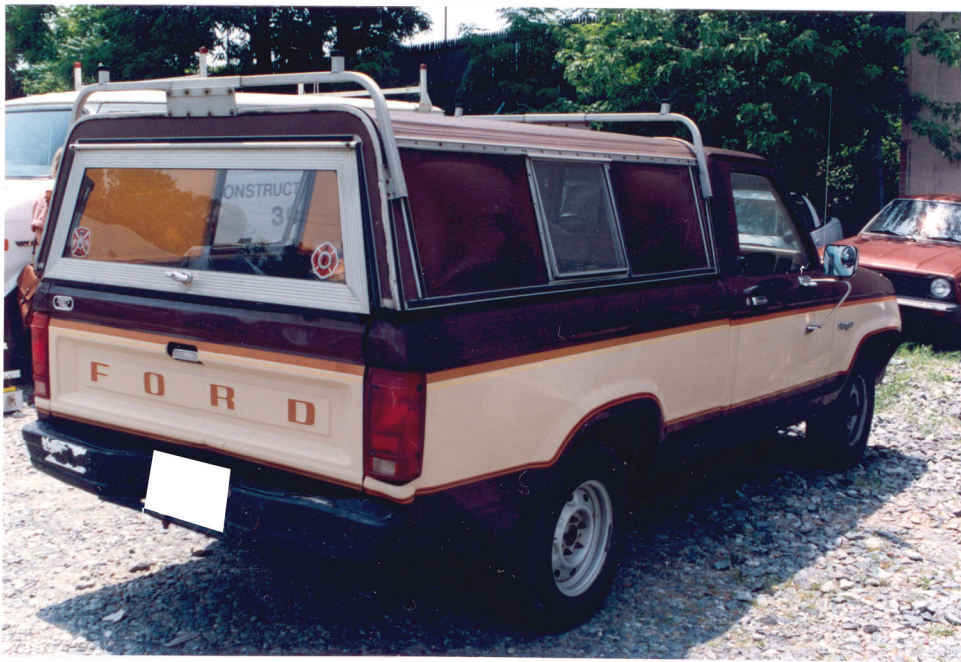
59. Right rear three-quarter view.
